Publication No 1/92 A Study of Tank Farm Fires in Kuwait

Publication 1/92

A Study of Tank Farm Fires in Kuwait

R A Bladon & S Miller

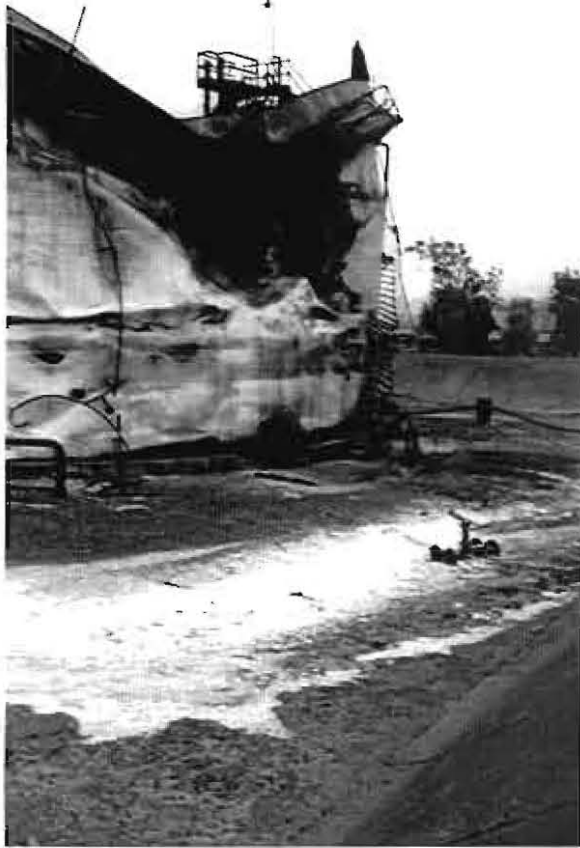
PLATE 1

MONITOR POSITION AND RESULTS TO THE TANK SHELL
FROM ITS COOLING JET

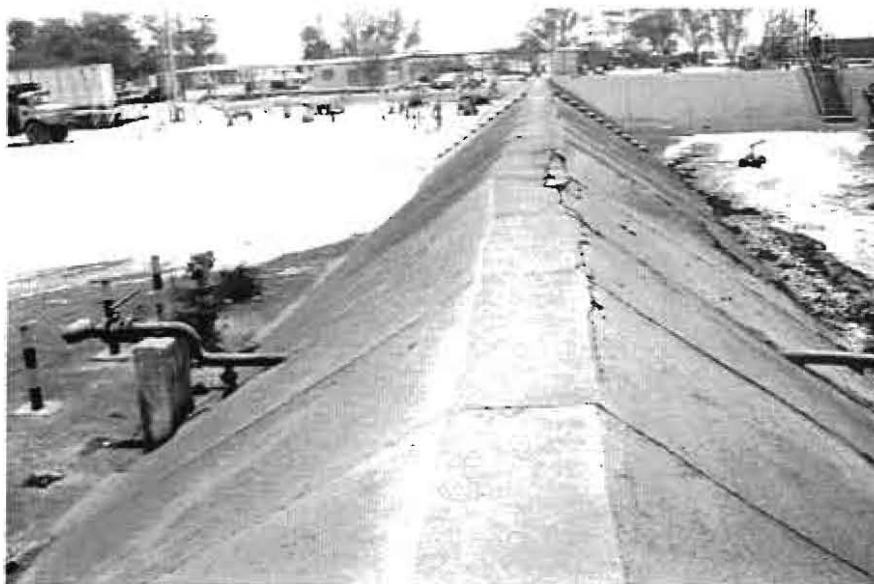
PLATE 2

The bund construction around these tanks is of compacted sand and gatch covered with oiled sand. Even though the 'wave' burning oil slopped over the bund, its integrity was maintained.

BUND CONSTRUCTION - TANK 77/101 NORTH PIER LOADING AREA

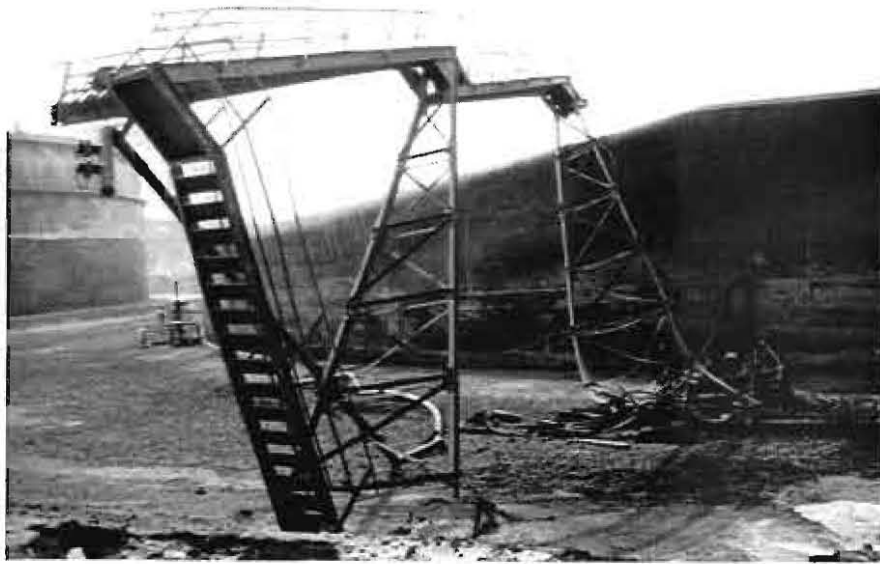
PLATE 7

Due to the occupation this fire was not fought and was allowed to burn itself out causing the tank shell in the area of the nozzles to collapse together with the top section of the stairway. As the foam pipework was supported from this stairway this also collapsed.

VULNERABILITY OF PLACING FOAM/WATER PIPES UP STAIRWAY

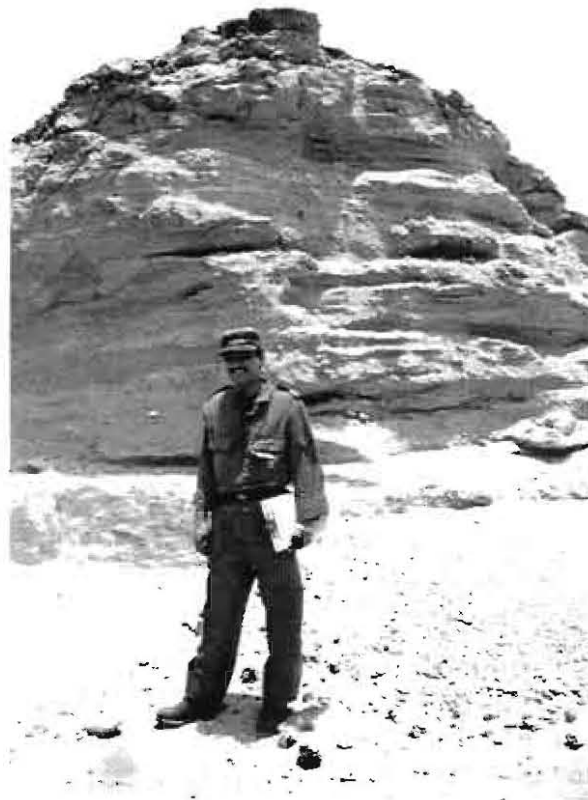
PLATE 12

CROSS SECTION OF SAND BUND (FIREFIGHTER SHOWS SCALE)

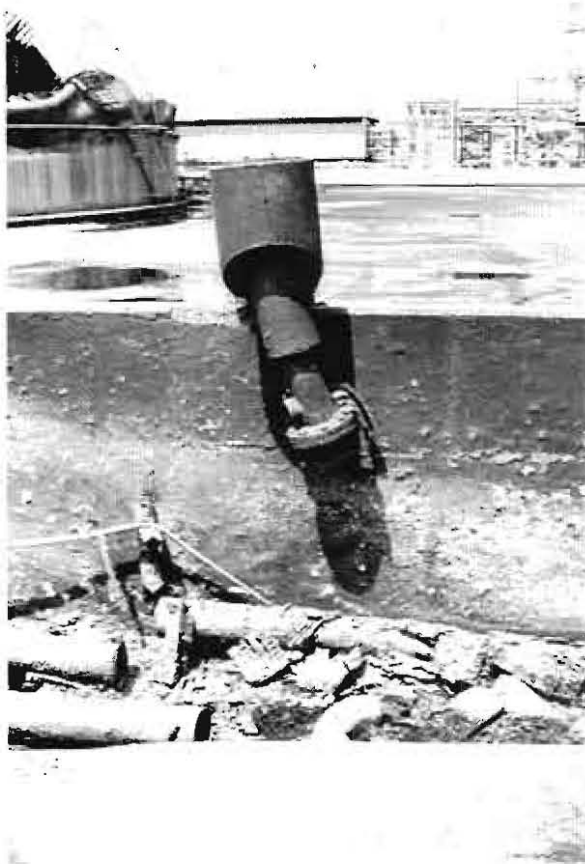
PLATE 15

FOAM POURER AND PIPEWORK DESTROYED BY FIRE

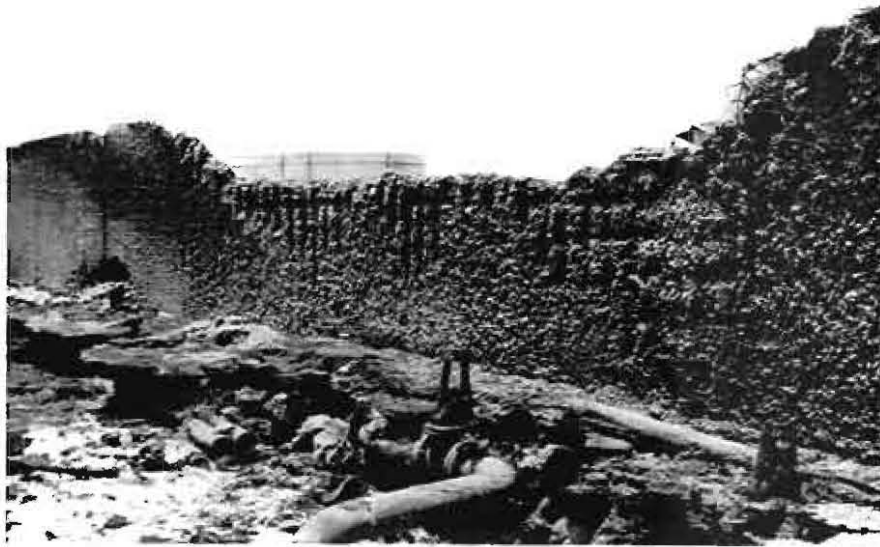
PLATE 17

Tank X, with a capacity of 16,000m³ was 80 percent full of Gas Oil when detonation charges were exploded at the inlet/outlet nozzle. This resulted in a "jet" fire with burning oil directed onto the adjacent concrete bund wall. The severity of the fire was sufficient to melt the concrete allowing a large quantity of burning oil to form a spill fire outside the bund. This spread along the adjoining roadway. (See Plate 17)

EFFECT OF FIRE ON CONCRETE BUND WALL

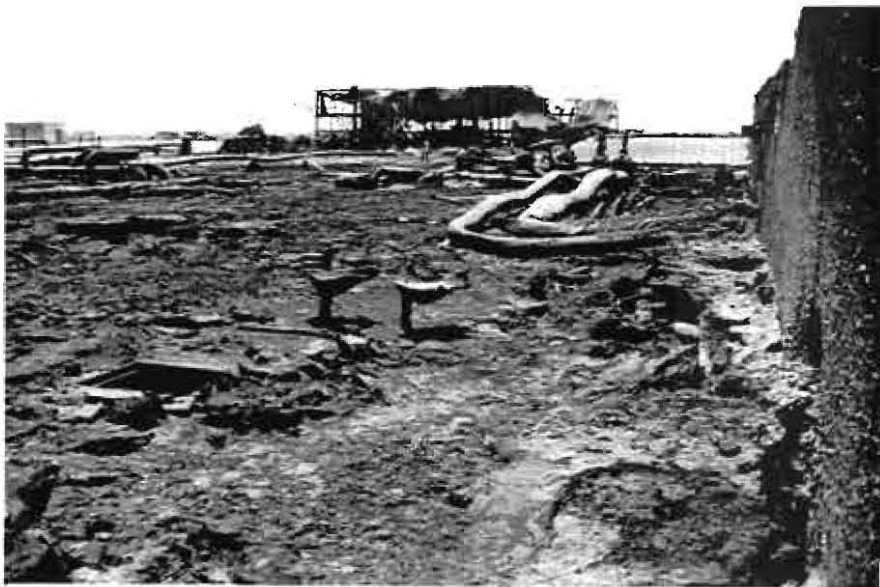
PLATE 18

From the coking and fire investigation it can be seen that the level of oil was approximately 0.6m deep just outside the damaged bund area (See Plate 18). This large quantity of oil spilt on such an extended area knocked out the fixed fire protection systems on the other tanks and all the product lines in this area.

SHOWING DEPTH TO WHICH OIL POOLED OUTSIDE BUND

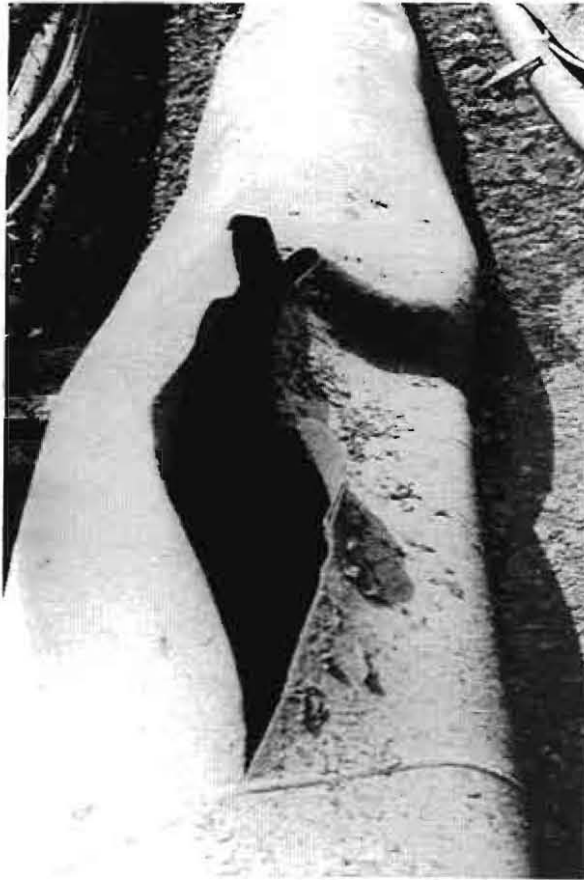
PLATE 19

The fracture of product lines caused by the spill fire contributed to the severity of the incident. (See Plate 19)

EFFECT OF FIRE ON PRODUCT LINE

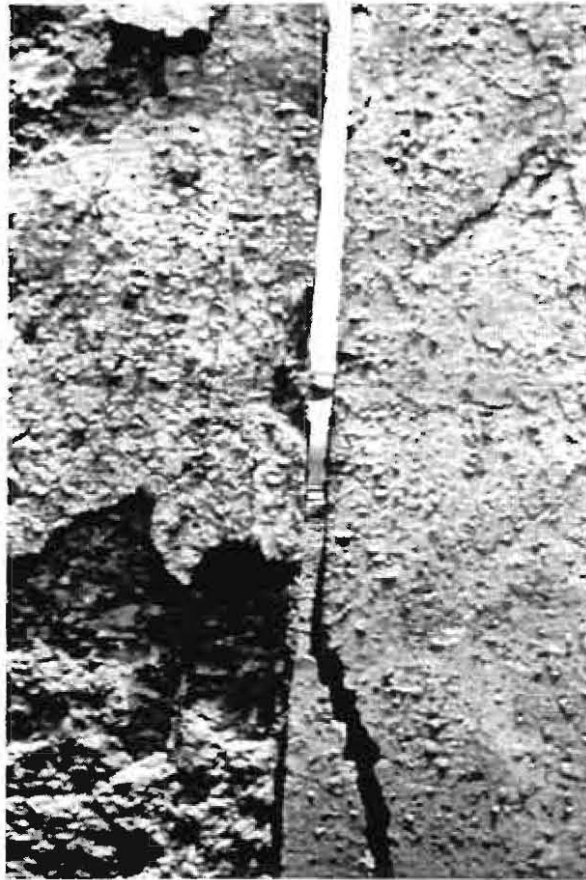
PLATE 20

As previously mentioned, the concrete bund wall was badly affected by fire from both inside and outside. The expansion joints had been burnt out with the result that gaps had opened up in the bund which had allowed oil to flow out. While it is recognised that these openings were not large enough to allow large quantities of oil to escape, it could contribute to a spill fire if only by concentrating burning oil on the product pipework running around the outside of the bund at ground level. (See Plate 20)

JOINT IN CONCRETE BUND WALL BURNT OUT BY SPILL FIRE

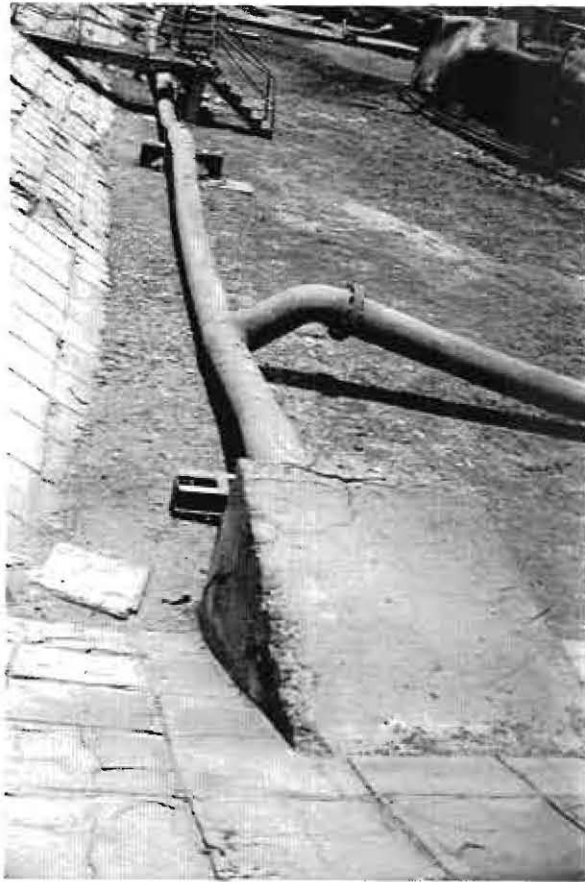
PLATE 22

It was noted that product piping passed through the bund walls. In some cases the sleeving had allowed oil to pass through, the spillage resulting in pool fires outside the bunded area, affecting the adjacent roadway.

On two identical installations where pipes passed through the bund, one sealed by means of concrete which did not breach, whilst a second was not and this one did. This sleeving through bunds is potentially hazardous as fire appliances, etc would be located on the roadway in the event of a tank fire or oil spill. (See Plates 22 and 23)

ARRANGEMENT FOR PIPE THROUGH BUND

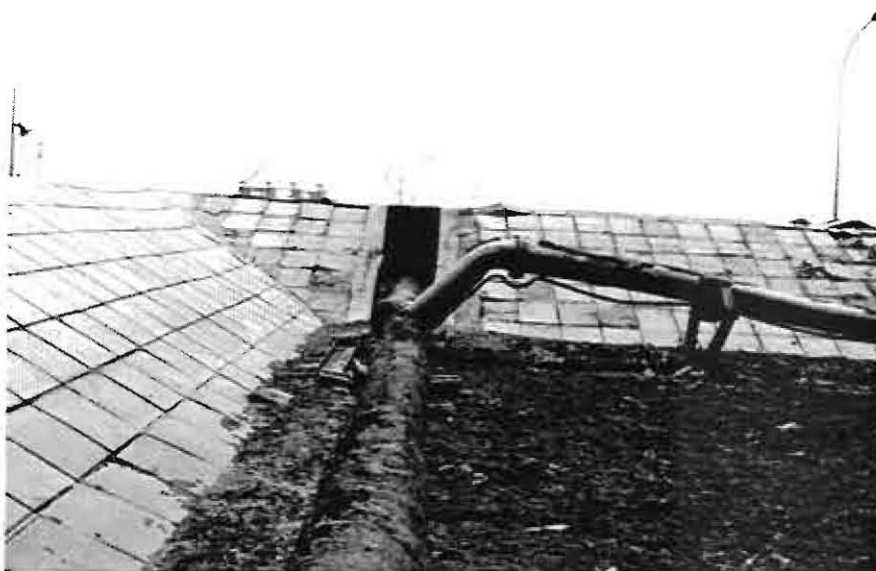
PLATE 23

ALTERNATIVE PIPE SLEAVING THROUGH BUND

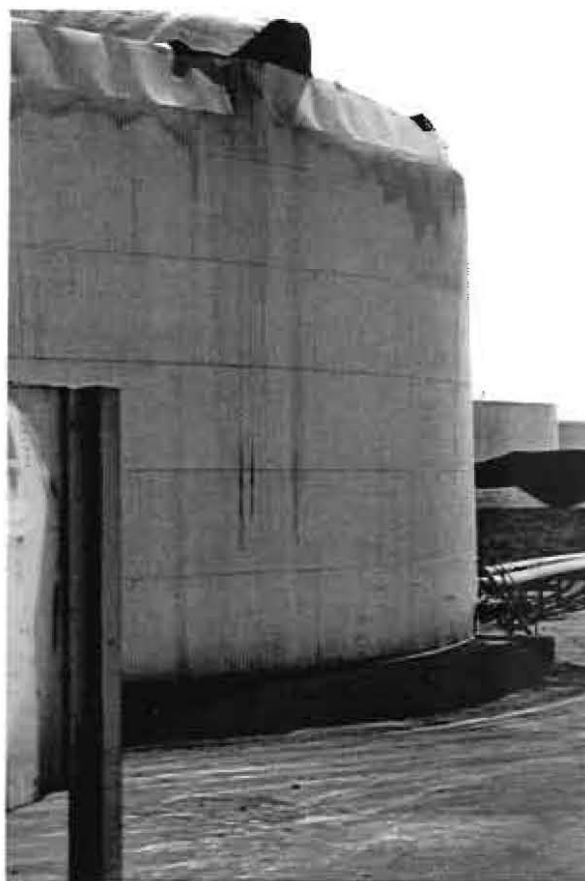
PLATE 25

EFFECT OF FULL SURFACE FIRE INSIDE FIXED ROOF TANK

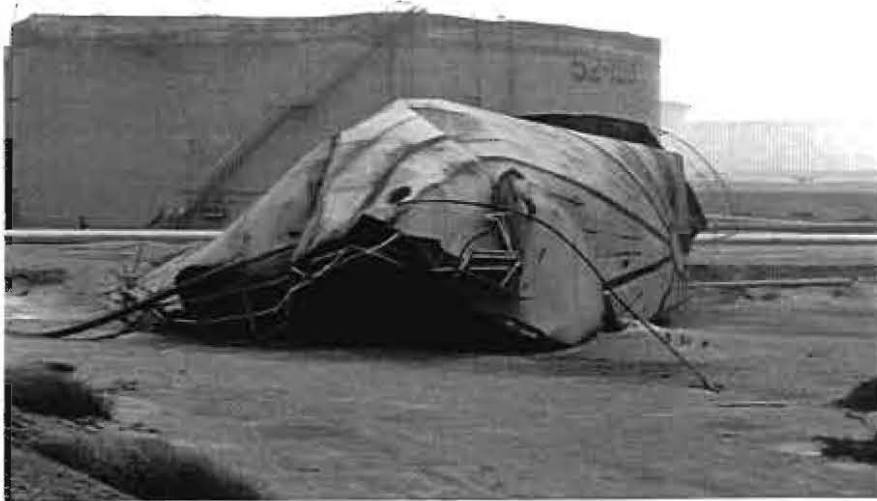
PLATE 27

FRANGIBLE ROOF BLOWN CLEAR OF TANK (IN BACKGROUND)
