Efficiency and Effectiveness of Sprinkler Systems in the United Kingdom: An Analysis from Fire Service Data

May 2017

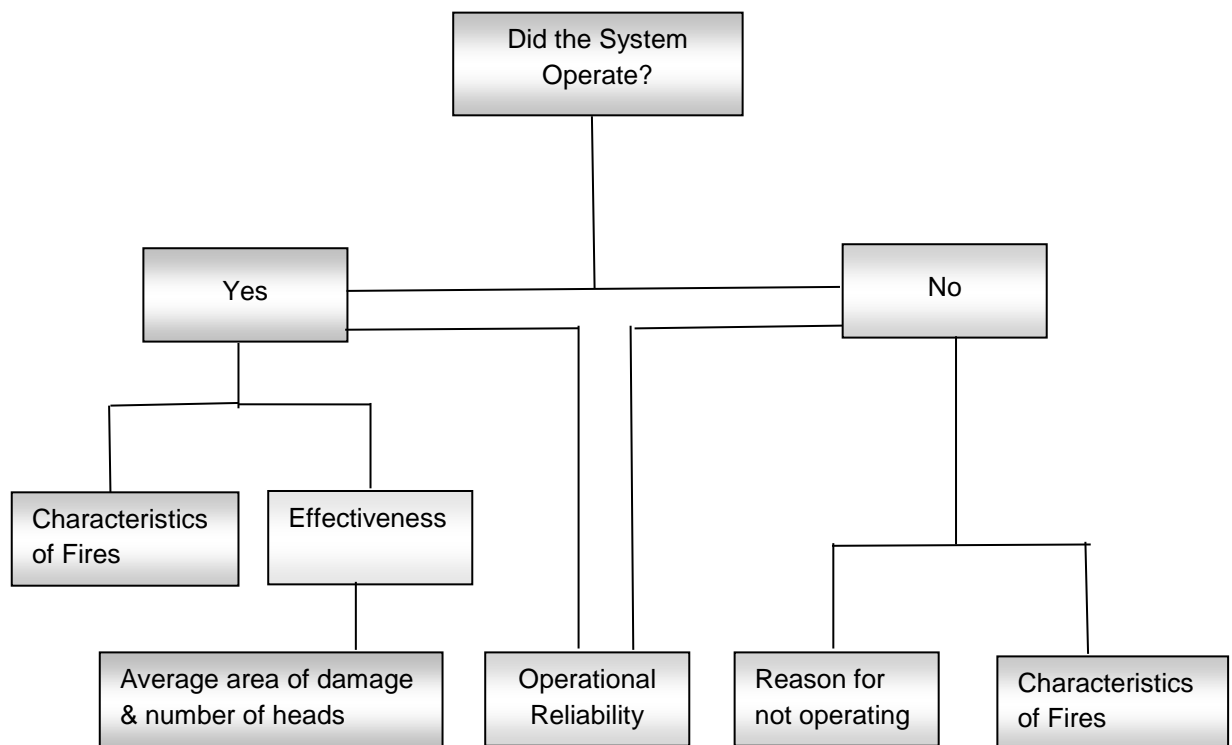
Figure 4: Framework for Analysis

2.2.3 The framework for the analysis is shown in Figure 4 and starts with the key question of whether the system operated. If the system did operate then the analysis establishes the characteristics of the fires e.g. where the fire was in relation to the sprinkler system (e.g. in the same room, on a different floor), how many heads activated and the extent of damage. The average area of damage and the average number heads activated are also estimated for those records where both the number of heads and area of damage has been provided. The impact of sprinklers on the fire (e.g. extinguished, contained/controlled) is analysed which enables the performance reliability or effectiveness of the system to be assessed.

- 2.2.4 If the sprinkler did not operate, the analysis considers the location of the fire in relation to the sprinklers and the reasons why the sprinkler did not operate. Where the system did not operate the analysis considers whether there are reasons that it could *not* be expected to operate e.g. because there was insufficient heat to activate the sprinkler heads. In assessing the operational reliability of the system the analysis takes account of circumstances where the sprinkler system could not be expected to operate.

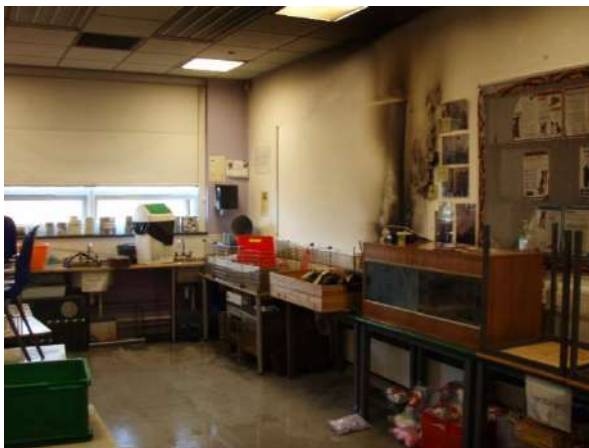
An electric heat lamp in the animal care classroom of a Newcastle school malfunctioned causing a fire with over 200 people on-site.

One sprinkler head activated which confined the damage to the room of origin and extinguished the fire.

A number of small animals were in the room involved and all survived whilst no other areas of the school were affected. Damage was limited to a wooden bench and minor smoke damage amounting to less than 1% of the whole building.

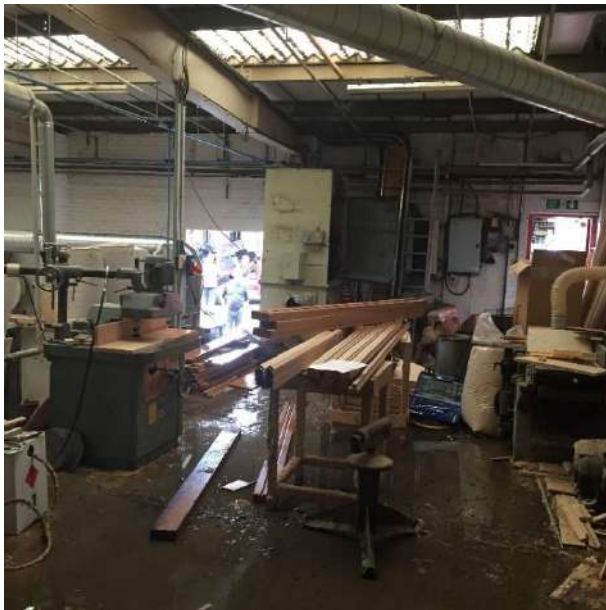
A fire was reported in a dust extraction unit at a joinery workshop in Nottingham.

The Fire Service found the fire was located inside the unit and that one sprinkler head above the unit had been activated. This had prevented the fire from spreading to other plant and materials. The unit was on fire internally and had badly smoke logged the workshop but, because the fire was contained, fire-fighters were able to extinguish it without too many problems

Fires in wood-working premises often take hold very quickly, resulting in extensive fire spread and damage. The sprinkler system had prevented this from happening.

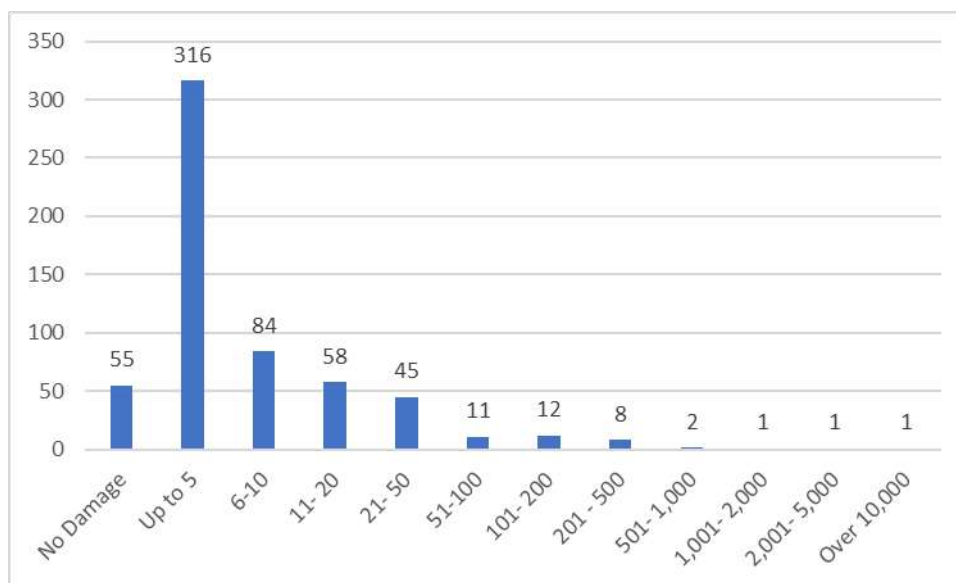
Figure 7: Number of Fires by Area of Fire Damage (sq. m.)

3.2.4 In terms of the area of fire damage, data are available for 594 fires where the system operated. The distribution of these fires by size of area damaged is shown in Figure 7. In the majority of fires where the sprinkler system operated there was a relatively small area of fire damage. Over 62% of the incidents had a fire damage area of up to 5 square metres (sq. m.) with a further 24% of fires having damage between 6 and 20 sq. m. Some 94% of fires where the area of damage is known had damage of less than 50 sq. m. There were no incidents in dwellings or other residential buildings which had an area of fire damage of over 100 sq. m. There was one fire where the area of damage was over 10,000 sq. m. and four fires with between 500 and 5,000 sq. m. of damage. All these fires were in non-residential buildings.

3.2.5 As a sprinkler system should provide sufficient water to control a fire, contact was made with the fire and rescue services reporting the very large fires to understand more about these cases. Further information was provided on three of the five very large fires:

- *Fire with over 10,000 sq. m. of damage:* This fire was in a factory manufacturing tissue paper. The manufacturing process produces a lot of paper fibres/lint which can accumulate around the building. In this case, there were sprinklers in the building, but the paper fibre/lint spread the fire. The dataset notes that only four sprinkler heads operated which is not consistent with damage of over 10,000 sq. m. as more sprinklers would be expected to open. It is possible that the recording of fire damage may not be accurate as there can be uncertainty between what constitutes fire and smoke damage.⁴ It is concluded that the fire damage in this case was likely to be less than the 10,000 sq. m. reported and the damage area can be considered an overstatement.

- *Fire with 2,001-5,000 sq. m. of damage:* This fire was in a plant that handled and recycled plastic hangers comprising two adjoining buildings. The first building was gutted by the fire but the second remains intact. This fire started outside the buildings in a variety of externally stored combustible materials but, due to the nature of the materials, the fire spread. The external fire spread caused an explosion amongst liquid petroleum gas containers which spread the fire significantly to nearby vehicles, further stored goods and then into the factory. The sprinkler system in the factory operated at an early stage, but was overwhelmed by the explosion. The sprinkler system in the warehouse also operated and helped to save the warehouse.

- *Fire 501-1,000 sq. m.:* This fire was in a machine that spread to the roof frame and ducting which made the sprinklers less effective.
- 3.2.6 The additional information provided for the very large fires highlights that specific instances contributed to the large areas of damage reported. However, these fires are very rare, accounting for less than 1% of all fires where the system operated and the area of damage is known.

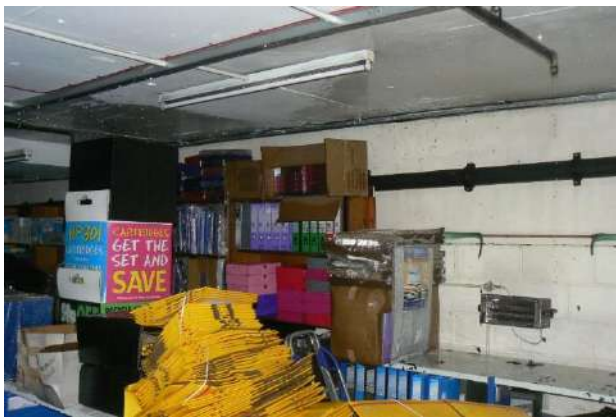
Fire-fighters were called to a shopping centre in Worcester after a fire broke out in the basement of a stationary shop where stock was stored.

There was a minimal amount of damage to stock from the fire and some water damage from the sprinklers. However, without the sprinklers operating, it is very doubtful that the shop would have been able to open for business on the day of the fire.

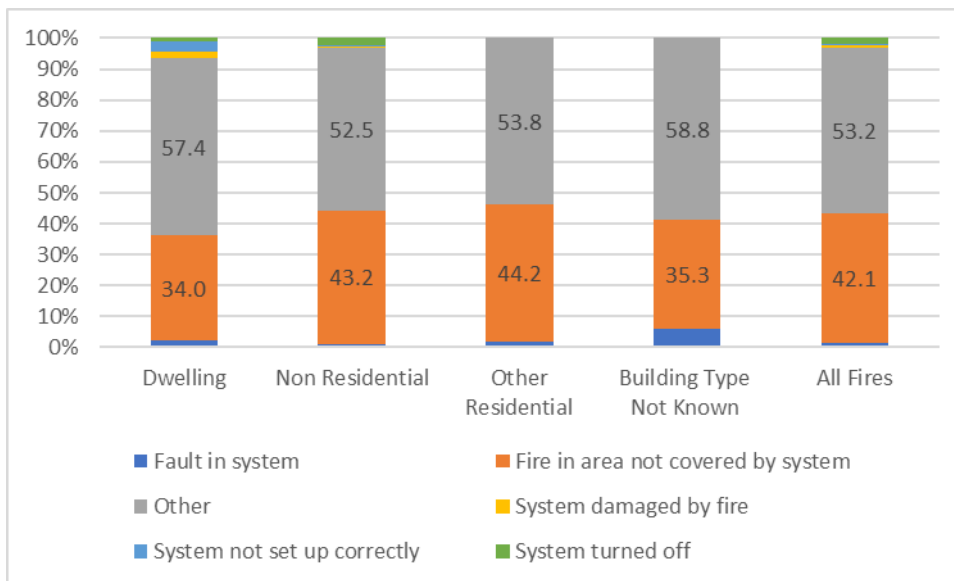
Figure 10: Reasons why Sprinkler System did not Operate by Building Type, %

3.3.3 Information on the reasons why the sprinkler system did not operate is available for 879 fires and these are shown in Figure 10. The reasons for the system not operating are dominated by two categories:

- Fault in the system – 12 incidents (1.4% of fires)
- System not set up properly – 4 incidents (0.5% of fires)
- System damaged by fire – 7 incidents (0.8% of fires)
- System turned off – 18 incidents (2% of fires).

- 3.3.5 Within the reporting system, there is scope to provide more information if “other” is given as the reason for the sprinkler system not operating. A total of 468 incidents (53% of fires) gave “other” as the reason for the system not operating and of these 145 provided further information which is shown in Table 5. Insufficient heat is the main reason for the system not operating.
- 3.3.6 Figure 11 shows the “other” reasons for the system not operating by building type. For dwellings and other residential buildings, insufficient heat was the only “other” reason cited for the system not operating.

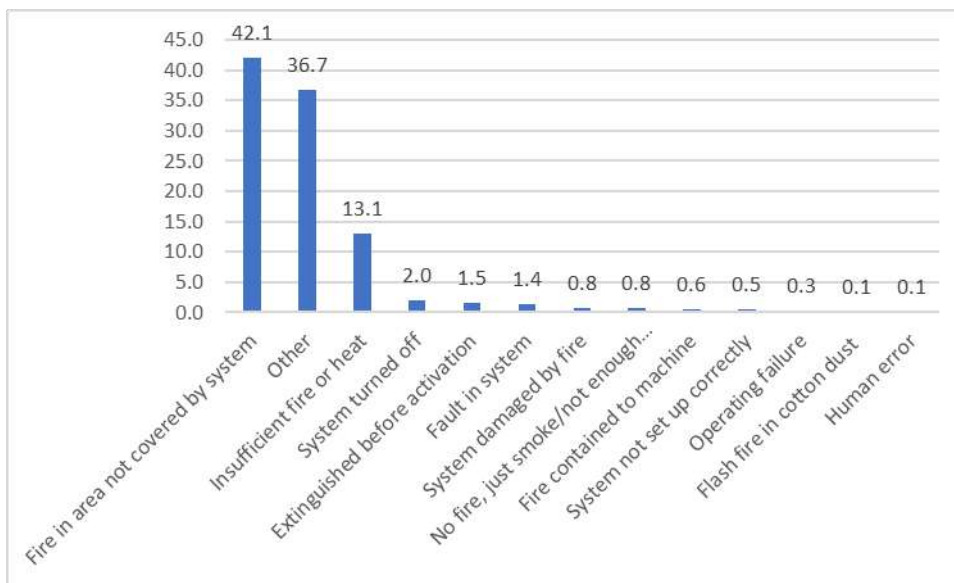
Figure 12: Distribution of Reasons for Sprinkler not Operating, %

3.3.8 Hence, in 58% of cases where the system did not operate, it was because it could not be expected to operate, primarily because the fire was in an area not covered by the system or there was insufficient fire or heat. Known cases of system failure are very rare with a fault in the system occurring in 12 cases (1.4% of fires) and operating failure occurring in three cases (0.3%) of fires. In 18 cases (2% of fires), the system was turned off. No further information is available to determine if the system was turned off or decommissioned. If decommissioned, the system could not have been expected to operate and would not be classified as a system failure. However, in the absence of additional information we have assumed that all fires where the system was turned off are system failures.

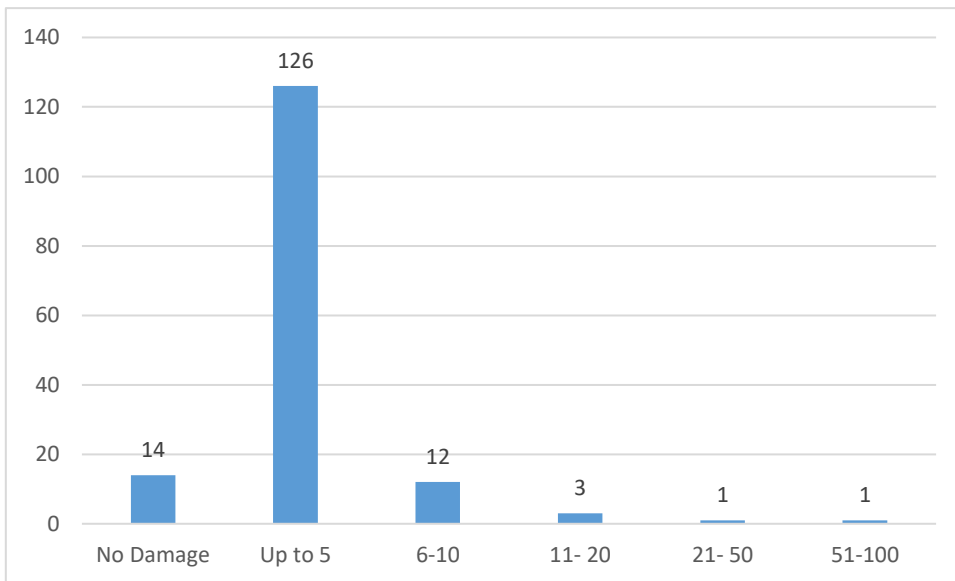
Figure B5: Number of Dwelling Fires by Area of Fire Damage, sq. m.

In terms of the area of fire damage where the sprinklers operated, data are available for 157 of the 276 fires. The number of fires by area is shown in Figure B5. Some 89% of fires had less than 5 sq. m. of fire damage.

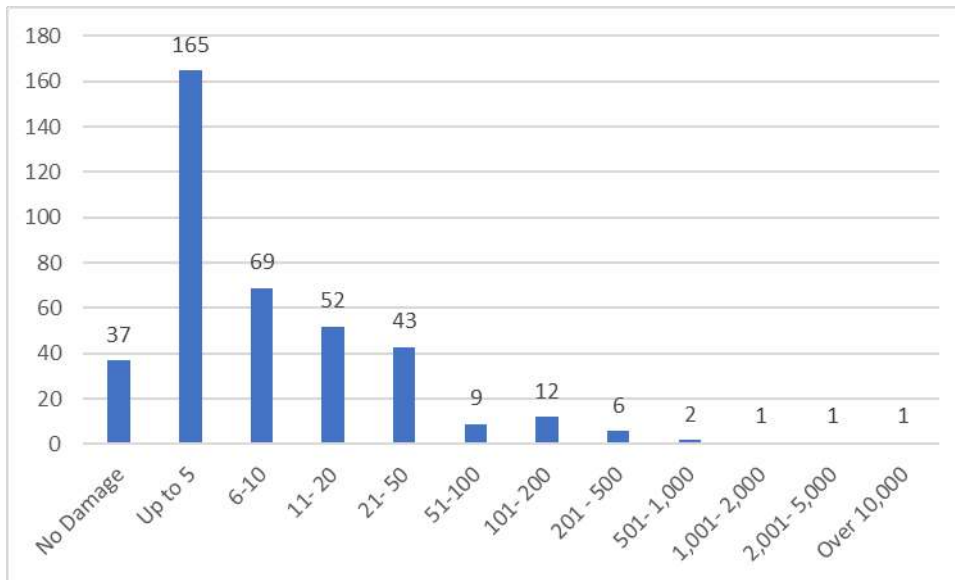
Figure B13: Number of Non-Residential Fires by Area of Fire Damage, sq. m.

In terms of the area of fire damage where the sprinklers operated, data are available for 398 fires and the number of cases by area of fire damage is shown in Figure B13. Some 68% of fires had less than 10 sq. m. of fire damage.
