Publication No 1/92 A Study of Tank Farm Fires in Kuwait

Publication 1/92

A Study of Tank Farm Fires in Kuwait

R A Bladon & S Miller

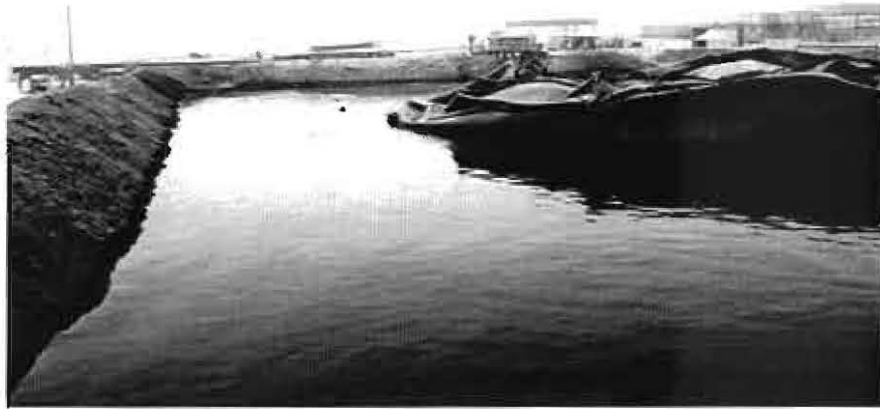
PLATE 3

The bund surrounding tank 204 was of similar construction to that of Tank 77/101, but instead of being covered with tarmac, it was covered by oiled sand. This would seem to be equally effective in preventing wind erosion, but might be prone to water erosion, and this bund had certainly prevented a large spill fire. This was particularly significant in that this facility was adjacent to a main road (See Plate 3).

BUND SURROUNDING TANK 204 SHOWING OIL CONTAINMENT

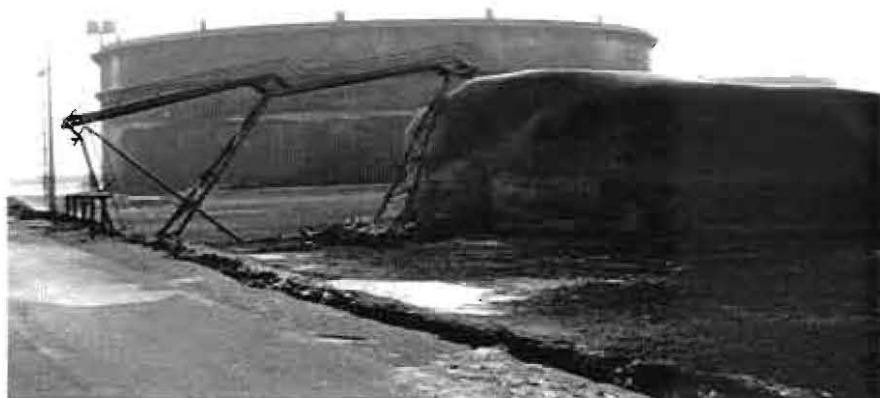
PLATE 4

Tank 52 was involved in a slopover. This was shown by the position of the floating roof. (See Plate 6). Tank 55 sustained only a rim seal fire even though it was closer to the first tank on fire (54) than 52. The line of damage to these tanks would imply that the wind direction helped to propagate the spread of the fire. Tanks 54 and 52 were completely destroyed whilst those around suffered comparatively less damage.

TANK 52 KOC NORTH TANK FARM

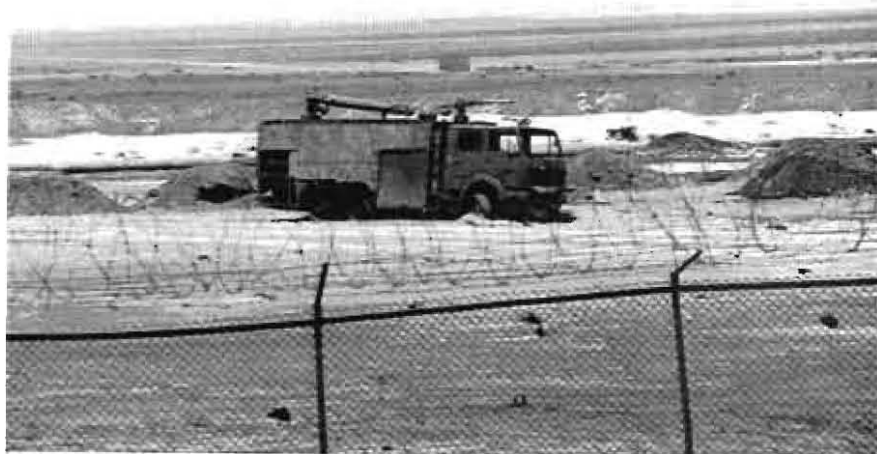
PLATE 5

Tank 54 is contained in a bund together with four other tanks of the same design, size and capacity. Due to the water storage tanks in the South Tank Farm being blown up, fire fighting was severely curtailed by the lack of water. Tank 54 was involved in a boilover which was witnessed by several firefighters. They described the event as being very violent and receiving short notice of the boilover about to occur. This was described as a change in the noise from the fire and the lightening of smoke. They had to retire so quickly that they were unable to save a foam tanker. (See Plate 5)

FOAM TENDER CAUGHT BY BOILOVER

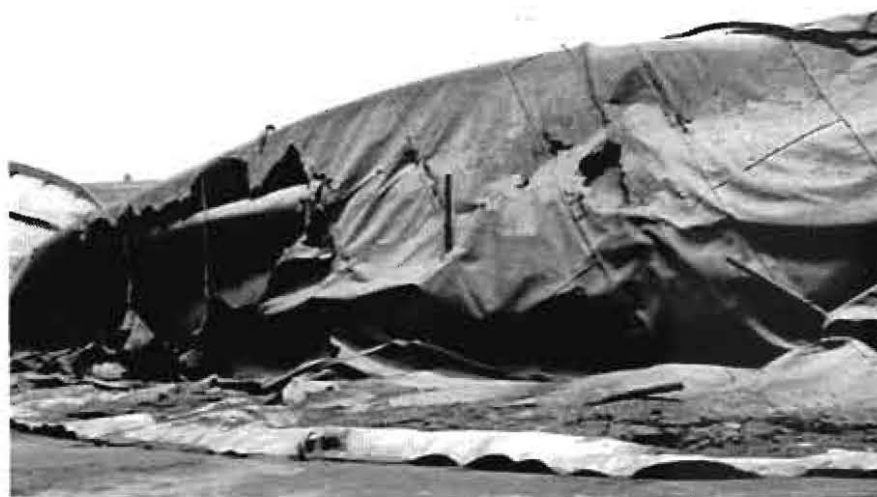
PLATE 6

FLOATING ROOF DISPLACED TO OUTSIDE OF TANK SHELL

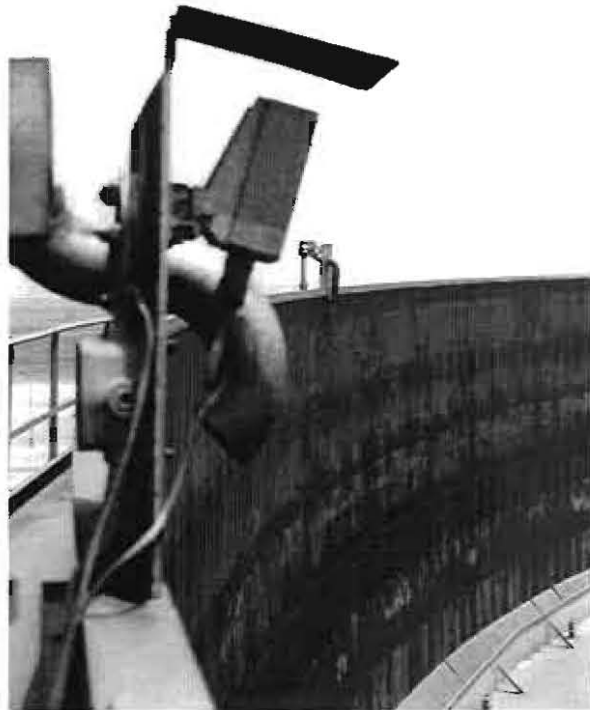
PLATE 8

Firefighters had experienced some difficulty with the foam pourers located around the circumference of the curb angle. During high winds the foam was blown away from the pourers as they discharged and before the foam started to run down the shell. (See Plate 8)

FOAM POURERS WITH MODIFIED POURER IN BACKGROUND

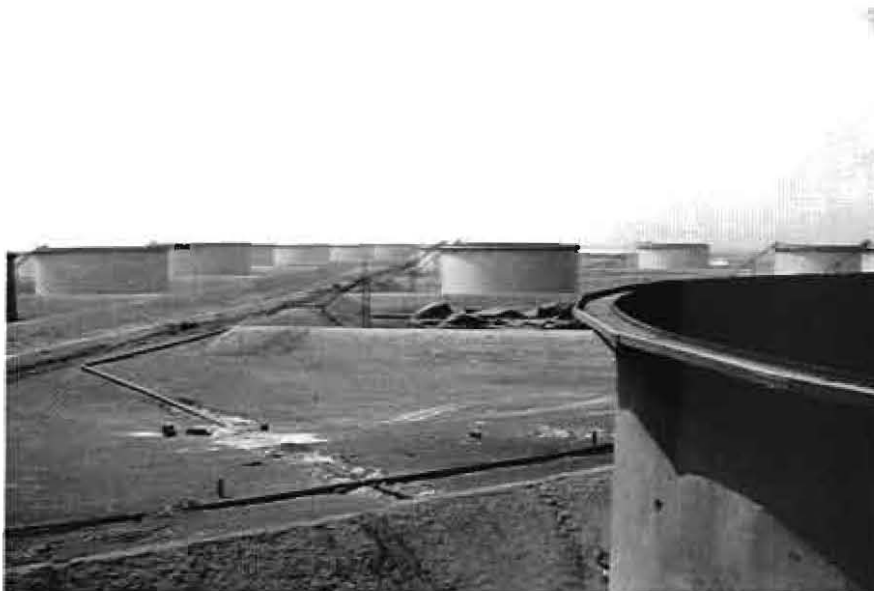
PLATE 9

GENERAL VIEW OVER K.O.C. SOUTH TANK FARM

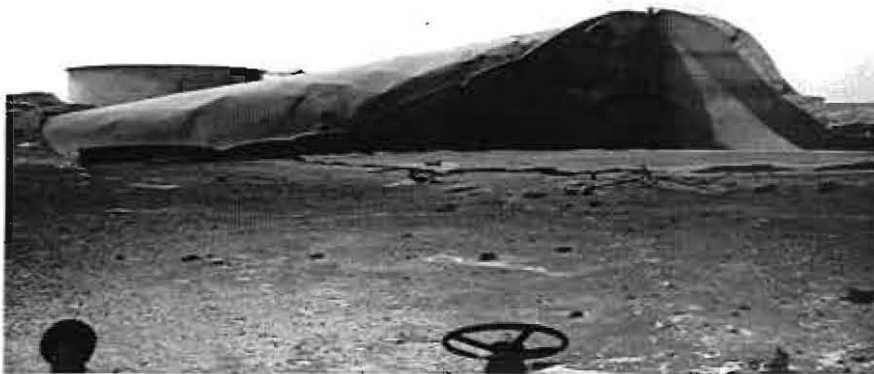
PLATE 10

Water storage tanks seemed to have been a priority target for sabotage and two 1.5 million gallon tanks had been completely destroyed. These tanks also fed the North Tank Farm mentioned previously. This had been achieved by blowing off the shell manhole creating a sudden outflow of water causing a vacuum resulting in a "rip/zip" effect splitting the shell from top to bottom. (See Plate 10)

RIP/ZIP WATER TANK

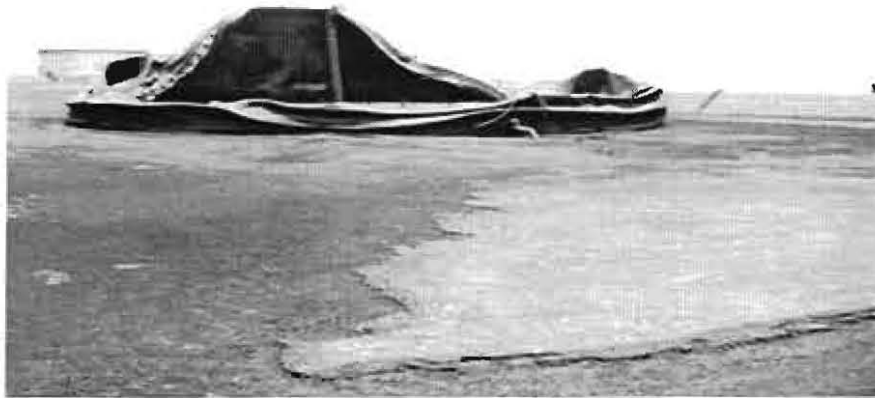
PLATE 11

TANK 62 - SOUTH TANK FARM

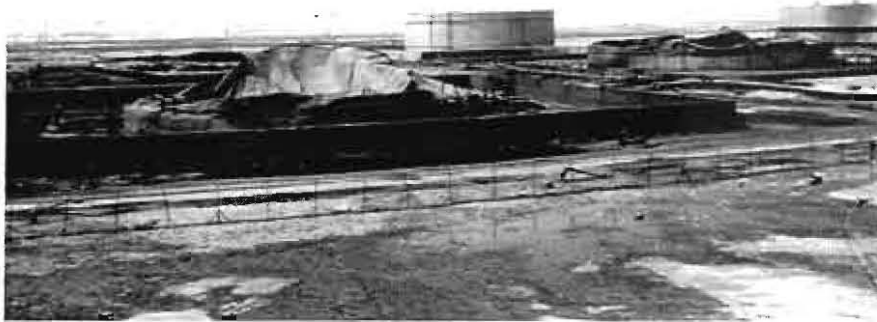
PLATE 13

DOHA POWER STATION TANK FARM

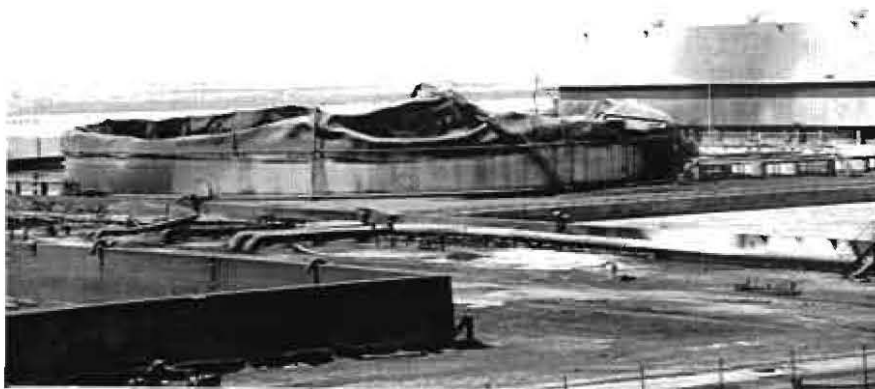
PLATE 14

TANK B DOHA POWER STATION

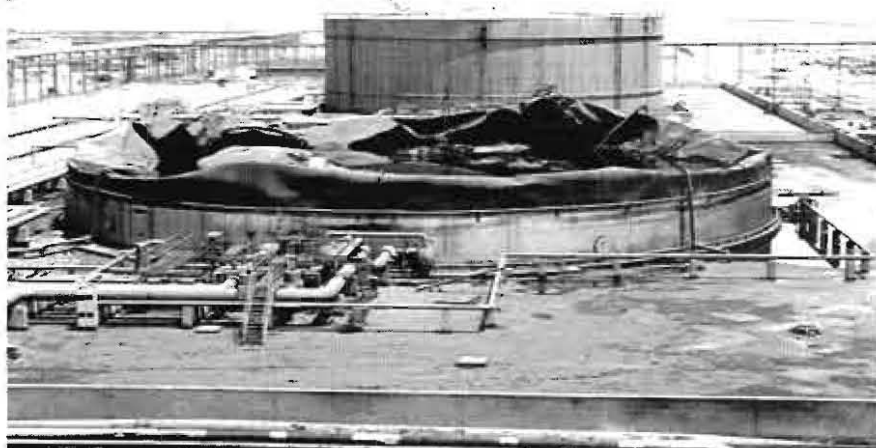
PLATE 16

GENERAL VIEW TANK B DESTROYED BY FIRE

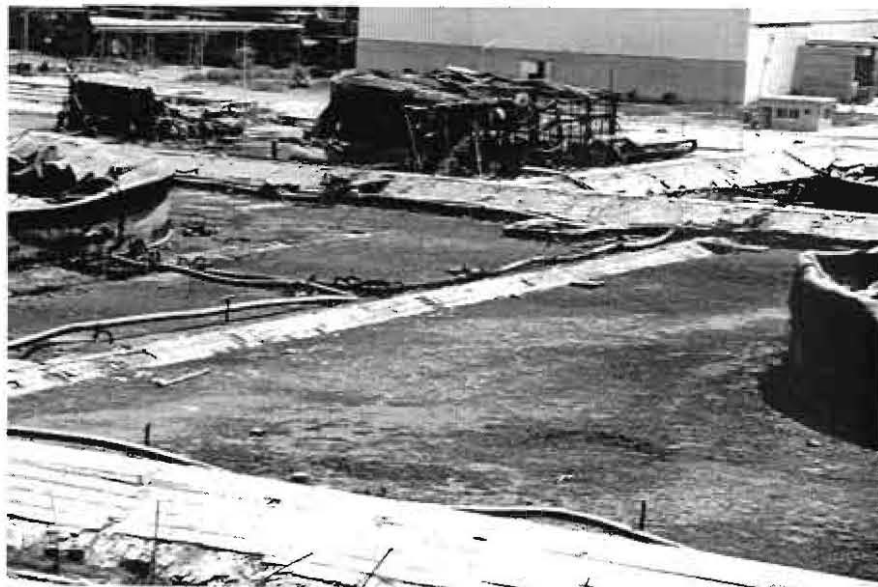
PLATE 21

TANKS Y AND Z GENERAL VIEW OF BUND ARRANGEMENT

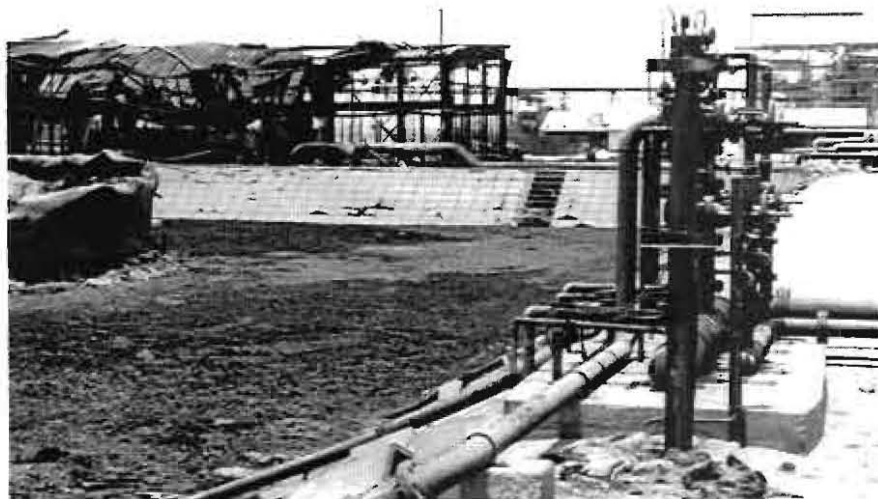
PLATE 24

FOAM INDUCTOR AND CONTROLS POSITIONED ON TOP OF BUND

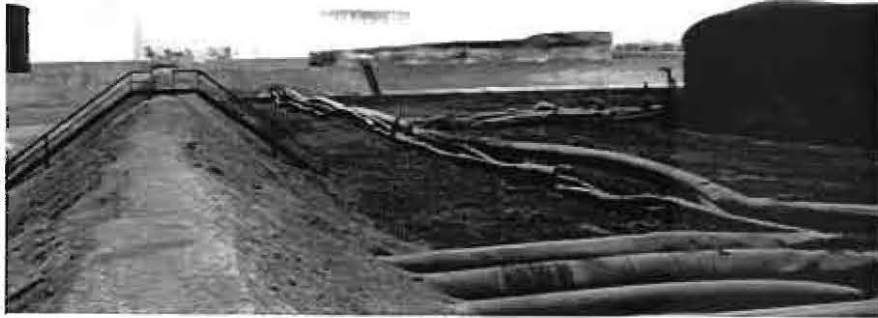
PLATE 26

FIRE SPREAD THROUGH SLEAVING BETWEEN BUNDS
